# SERVICE BULLETIN 15

Section VIII, Division A  
Service Bulletin  
Issued March 1963

SUBJECT: WESTERN AUTO SUPPLY COMPANY  
Western Auto Imperial Tiller Model 4XC-6390  
Clinton Engine Model 404-0011-081

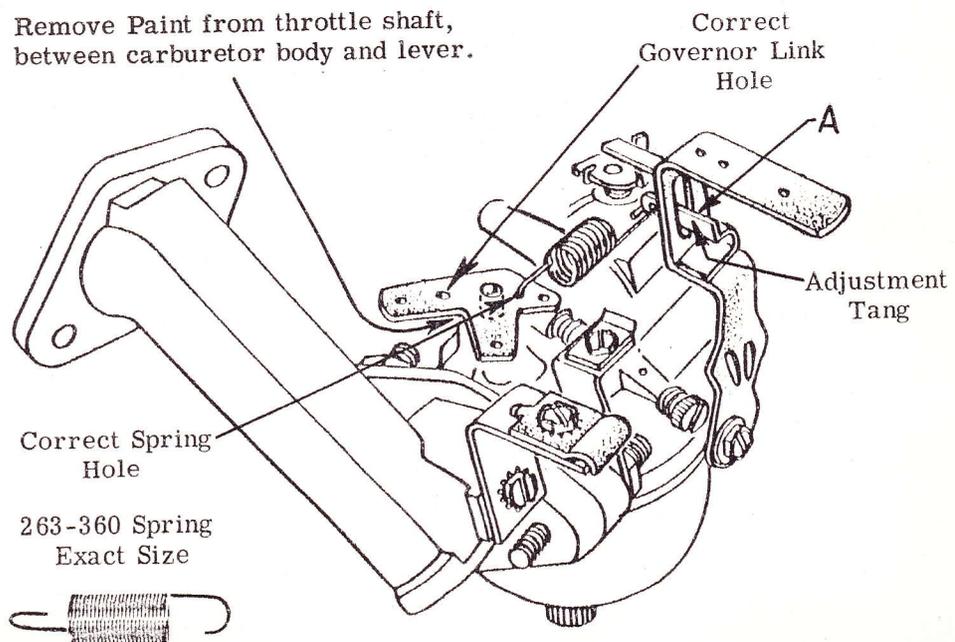
A limited quantity of the above-listed engines (404-0011-081) were shipped from our factory, with governor springs that allowed the no-load operating speed to exceed 3600 R. P. M. In some instances, the spring coils may have been spread apart by factory personnel in an effort to reduce engine speed.

Excessive paint on throttle shaft may cause it to bind. Remove paint to allow free movement of shaft.

After completing necessary repairs, check the governor spring for correct length, it should be 1-1/8" long, if distorted, too long or too short, replace with a new Part No. 263-360 Spring. Illustrated below is correct hook up of the spring and the governor link, do not deviate.

Point "A" shows the tang that may be bent to adjust maximum no-load speed to 3,600 RPM. Check remote control cable to allow full choking and engine shut-off.
