# SERVICE BULLETIN NO. 16

SEC. VIII, DIV. A  
SERVICE BULLETINS  
ISSUED SEPTEMBER, 1963

A Field Fix has been designed to eliminate a surging condition found on some Vertical Shaft engines.

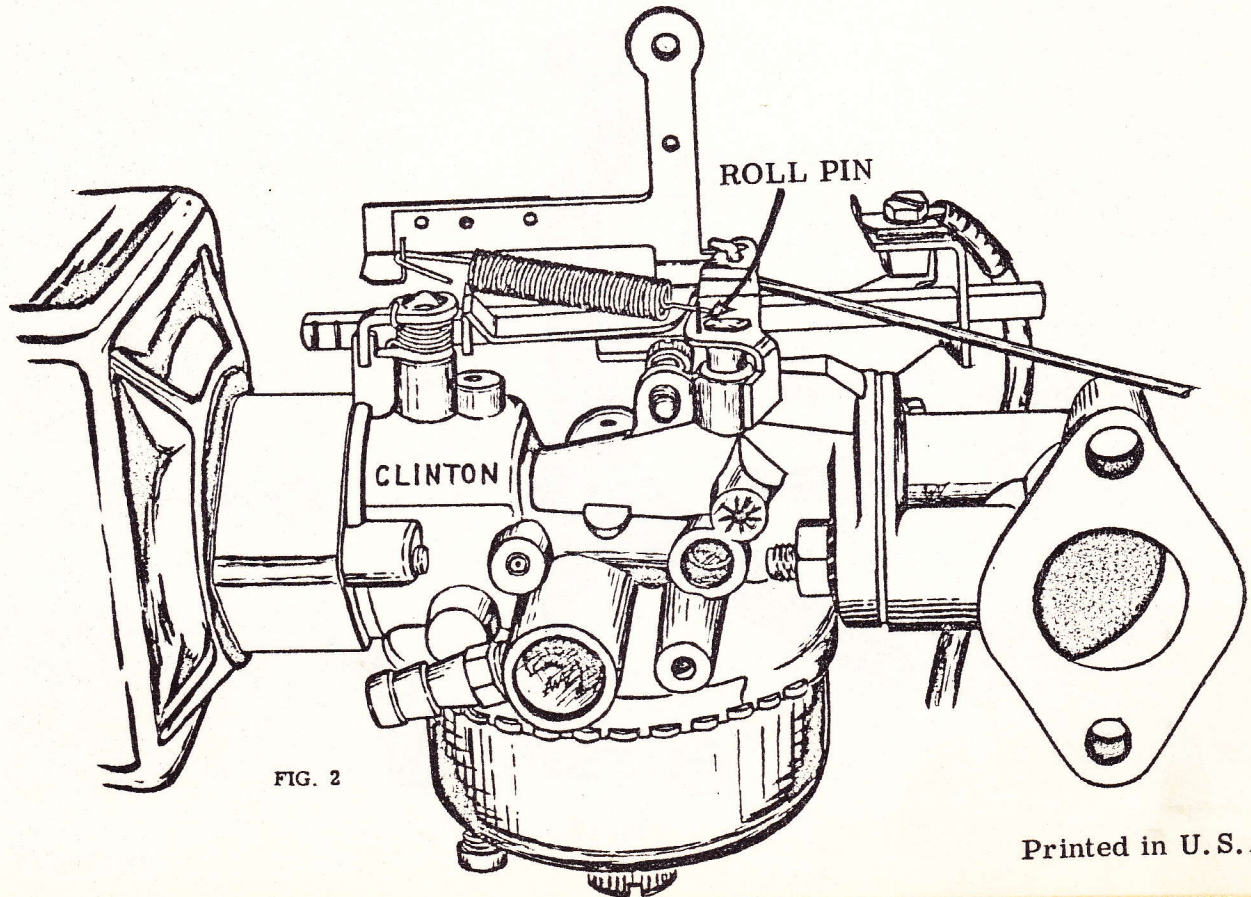
FIG. 2

Proper Spring installation (as illustrated) is important.

A replacement Throttle Shaft & Lever Assembly, Part No. 6-441-500, which incorporates a Roll Pin to stabilize the Governor during the entire operating range should be used in place of 6-108-500. This Shaft & Lever is used on the following:
