SERVICE BULLETIN

No. 8

SEC. VIII
SERVICE BULLETIN
ISSUED MARCH, 1962
REVISED MAY, 1962

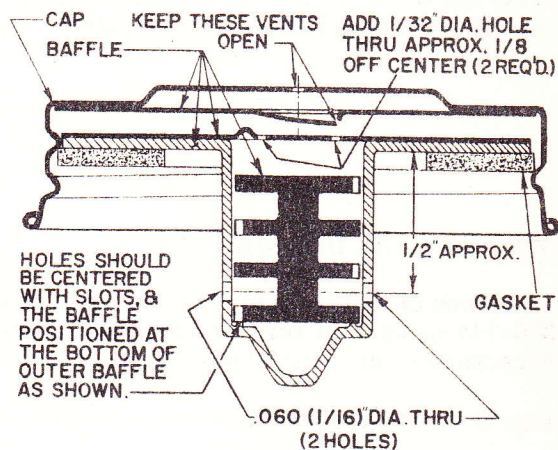
SUBJECT: FUEL TANK CAP

If a problem in high speed or idle setting is noted; loosen fuel cap to see if this affects the setting.

If Carburetor adjustment is affected by loosening cap, remove cap and disassemble. Drill two holes approximately $1/16"$ and not over $3/32"$ as illustrated. This secures adequate atmospheric venting.

An additional hole ($1/32"$) should be added to center baffle. Clean parts prior to reassembly.

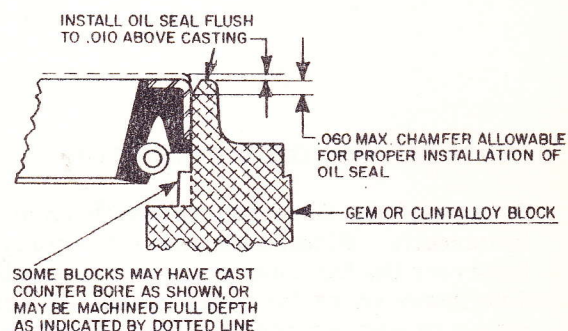
SUBJECT: BLOCK OIL SEAL INSTALLATION 4 CYCLE ALUMALLOY

Figure illustrates the proper depth of installation for the Oil Seal in either Vertical or Horizontal 4 Cycle Alumalloy (400, 401, 402, 403, 404, 405, 408 & 409) also 4 Cycle Clintalloy models (406, 407 & 424); also Horizontal & Vertical Gem & Clintalloy models (100, 2100, 3000, 3100 & 4100).

In some cases the Oil Seal can be installed too far into the counterbore causing the lip of the Seal to touch the edge of the Block Bearing. This can result in Seal leakage due to the contact. Installation of Oil Seals is covered also in Sec. VI, Div. C, Pages 8, 12, 13 & 14.

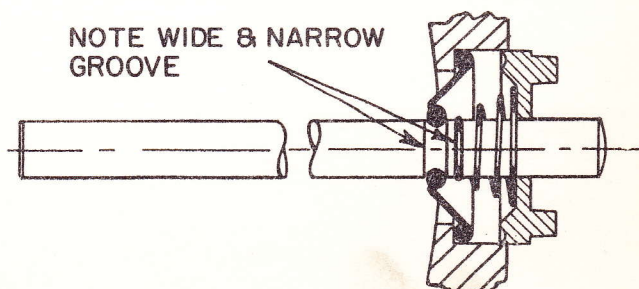
SUBJECT: INSTALLATION OF BREAKER SEAL, SPRING, PUSH ROD & SEAL ON A1600, 1800, B2500, 2790, 414, 418, 420 & 422 SERIES

The proper assembly of the parts illustrated will prevent Oil from leaking into the Breaker Point area. Note the position of the Seal & Spring. Replace worn or damaged parts prior to reassembly.

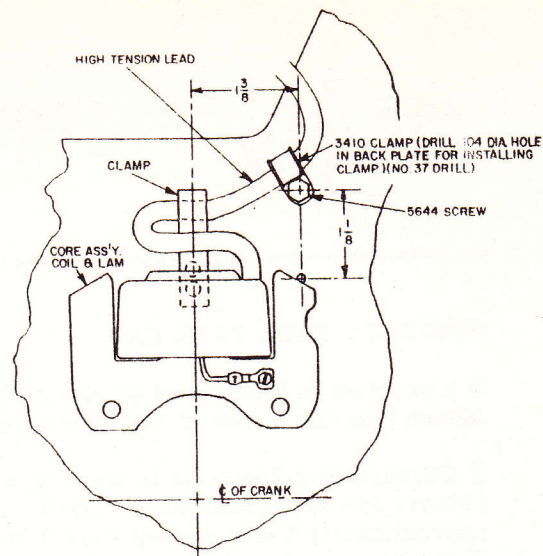
SUBJECT: FRAYING OF HI TENSION LEAD
(Models-A1600, 1800, B2500 & 2790)

Figure illustrates the addition of and positioning of a 3410 Clamp and 5644 Screw. Should fraying of hi-tension lead be caused by contact with Flywheel, the fastening of Lead as illustrated, will remove the reoccurrence of the problem. If leakage has been experienced on the hi-tension lead, replace with a new lead and then fasten as illustrated.

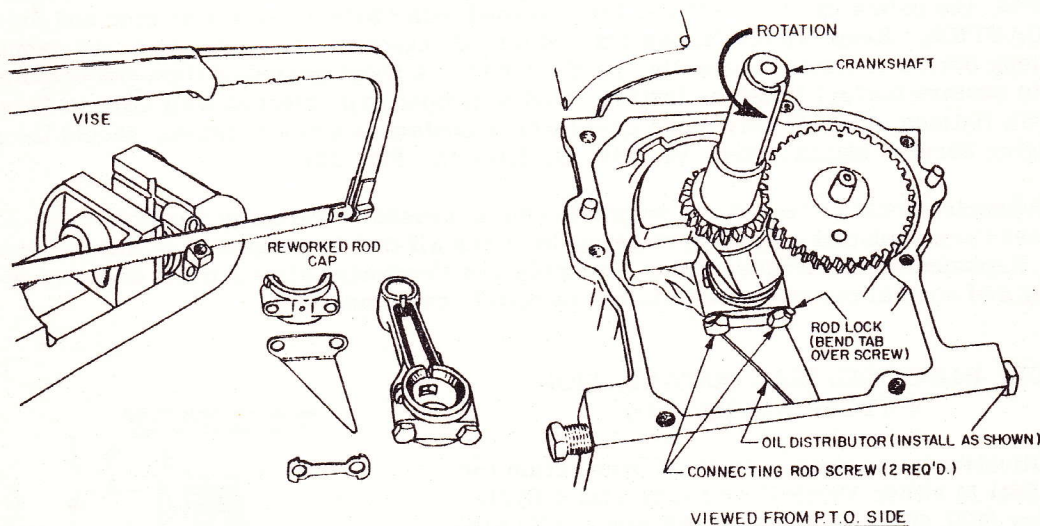
SUBJECT: OIL DISTRIBUTORS

The Stock of 31017-1 Oil Distributor is exhausted at the factory and this will require that Oil Distributor 220-147 be used in service when field stock used up. Fig. 1 illustrates Rods with oil scoop & removal is necessary to use Distributor 220-147.

Fig. 2 illustrates Oil Distributor in place and 31018 Rod Lock should be used with 220-147 Oil Distributor.

NOTE: If Rod is held in vise, protect Rod face's from burring or damage also smooth Rod Cap after cup cut-off to secure smooth flat surface for distributor.
