FV3100 Engine Speed Variation

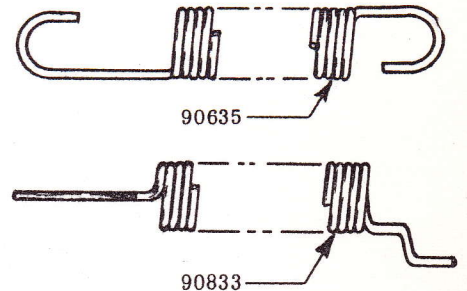
NOTE: Fig. 1 illustrates the 90635 spring and also the 90833 spring.

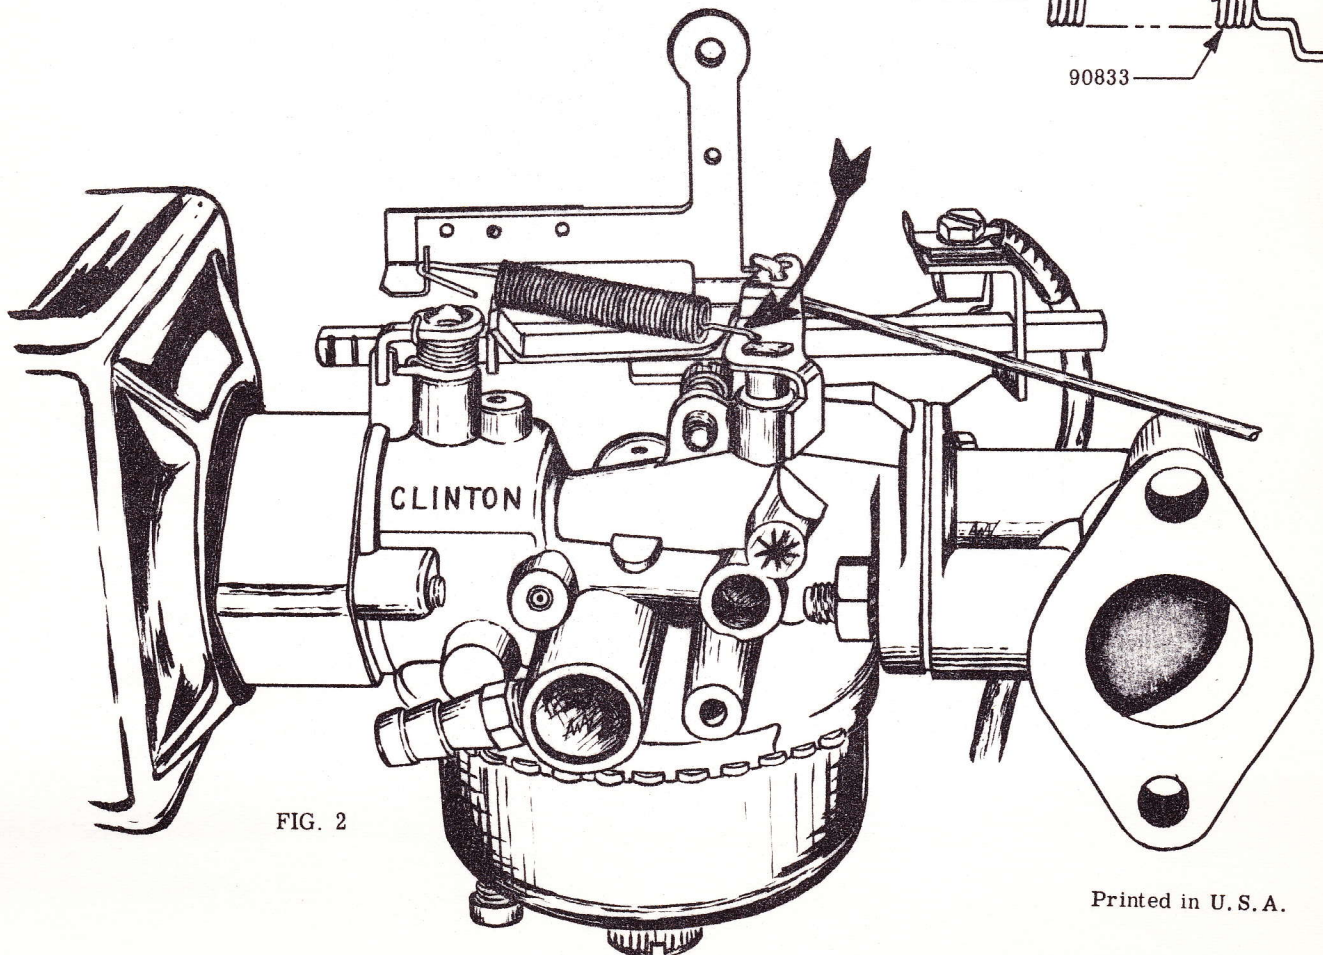
Fig. 2 illustrates 90833 governor spring installed. It should be installed in the hole in the throttle lever closest to the throttle shaft. The 90635 spring was installed in a special location (on FV3100-1115) which is not to be used for the 90833 spring.

After installation, check to be certain that the spring does not drag across the throttle lever when in any position other than idle as a contact across the throttle lever can cause this surging. The arrow in Fig. 2 points to the place where drag is to be avoided.

The spring 90833 should be installed on this engine (FV3100-1115) whenever a surging is experienced, thus removing the possibility that this could be caused by governor spring.

When changing spring, check link and throttle lever to be certain of free movement of these parts. The same surging problem can occur as a result of damage in shipment of engines, units, or due to previous improper service or adjustment.

- A. For drag of spring end on throttle lever plate.
- B. For free movement of governor link and throttle lever.
- C. For proper carburetor adjustment.
