SECTION VI
DIVISION D
SERVICE MANUAL
ISSUED FEB., 1960

MAGNETOS

CLINTON ENGINES CORPORATION, Maquoketa, Iowa

SECTION VI, DIVISION D
SERVICE MANUAL
Issued February, 1960

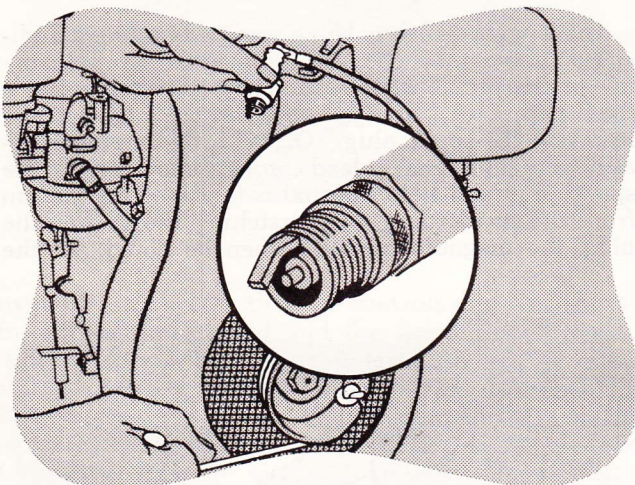
Fig. 1

To check magneto output, it is recommended that an 18 mm spark plug (Fig. 1) be used and that the

ground electrode of the spark plug be bent away from the center electrode up to $\frac{3}{16}$ " (.187) and at least $\frac{5}{32}$ " (.156). Using a fixed gap in the range of .156 to .187 (that is, $\frac{5}{32}$ " to $\frac{3}{16}$ ") the high tension lead can be removed from the engine and fastened to this gapped plug. Then hold the hex or threaded portion of the spark plug (Fig. 1) against the engine head or block and crank the engine in a normal manner with rope or recoil at a normal cranking speed. If the fire jumps the gap readily and steadily at a normal cranking speed across the $\frac{5}{32}$ " to $\frac{3}{16}$ " gap, the magneto output is adequate to fire the engine under compression.

As the starter cup is replaced, a lockwasher and a flywheel nut are used, which should be torqued, according to the specifications listed in Section VI, Torque Data. As the unit is reassembled, the magneto output can be checked (Fig. 1) as soon as the starter cup is applied and the flywheel nut tightened to be sure that the magneto malfunction has been corrected. With the spark plug out of the engine, and the flywheel tight, it can be spun by hand and fire checked over a fixed gap.

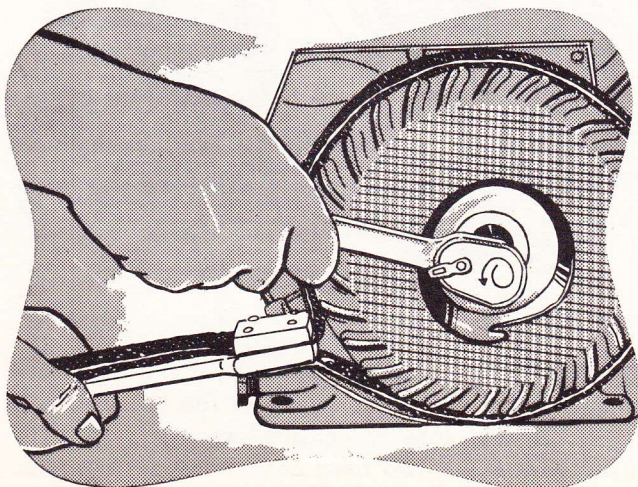
Fig. 7

To inspect the magneto assembly, remove the blower housing to expose the flywheel. To remove the flywheel, use holder #TL-938 to hold the fly-

wheel and remove the flywheel nut in a counter-clockwise direction (See Fig. 7). After the flywheel nut is removed, remove starter cup, recoil cup and/or screen, depending upon the assembly. Then use the flywheel puller #TL-969 (Fig. 8) to loosen flywheel. To use this flywheel puller, tighten the center screw down about 100-inch-pounds or more and then rap the end of the screw with a steel hammer to impact the flywheel loose. The flywheel may be loosened as well with #TL-916 for the $\frac{7}{16}$ " thread crankshaft and #TL-968 for the $\frac{1}{2}$ " thread crankshaft. When using the impact nut, turn nut within $\frac{1}{8}$ " of the flywheel and then strike with a steel hammer. It will aid in flywheel removal, if the flywheel is gripped by the fingers and the weight of the engine is partially supported in this way when the nut is struck (Fig. 9). It is not recommended that screw drivers

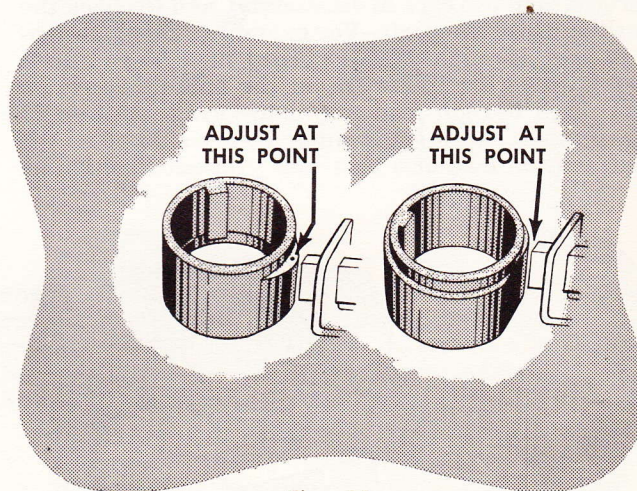
2. If the point setting is off, it can also indicate that the point was not in the proper place on the cam lobe when they were set. Fig. 11 illustrates the two most common types of cams, which have been used on engines other than Red

Horse series, and at which point on the cam the point adjustment should be made. Refer to Section VI, Service Clearances for Point Setting of the Respective Engine. Fig. 12 illustrates breaker points and common terminology.

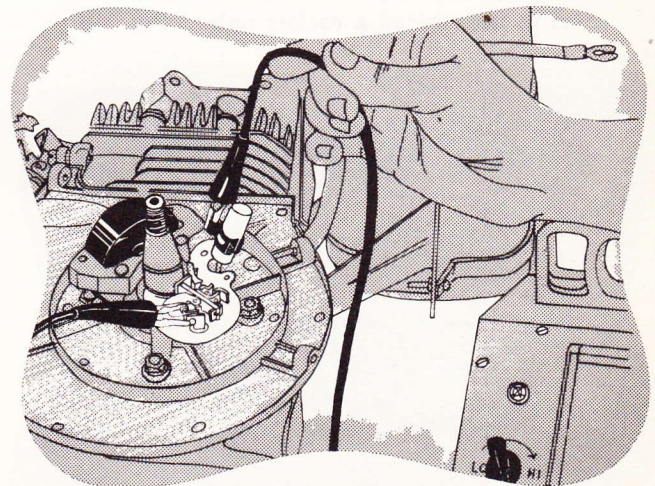
Fig. 18

(Fig. 17 illustrates a condenser and terminology.) The condenser should be checked for capacity, and leakage, while servicing a magneto (Fig. 18), and also for series resistance (if tester is so equipped).

An important check on a condenser and one of the harder tests to perform accurately is the leakage test which checks the quality of the insulation between the condenser foils or plates. On the previously mentioned condensers, two megohm leakage is allowable on a leakage test.

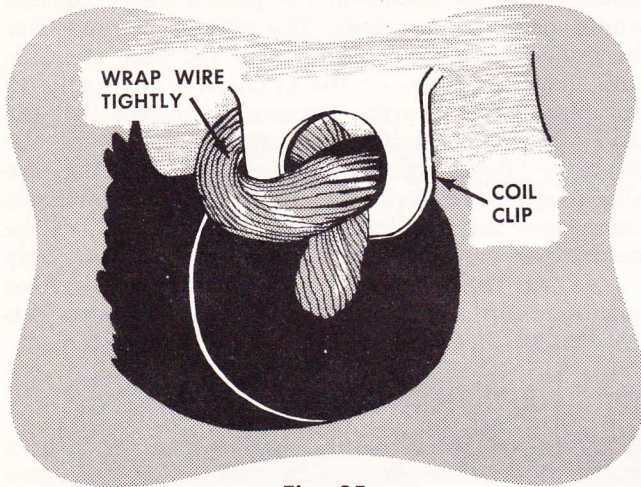
Fig. 25

coil being serviced, wrap it tightly around the coil clip as illustrated in Fig. 25, but **under no circumstances should it be soldered to this clip.** However, if it is hanging loosely to the clip on the coil, it can give a surge in the engine due to the vibration of the high tension lead to the clip. If a high tension lead is being reused, see that all of the wires are tightly twisted together prior to attempting to insert them through this clip. The end of the high tension lead can be heated by use of a torch or soldering iron, and the strands twisted together so the existing solder on the lead will hold the strands together for insertion through and winding around this clip. **Do not add solder** to the ends of these high tension leads as the wrong type of solder can give a residue on the outside of the insulation that can give the electricity a path to "short out" to the bearing plate or block. Use care in this connection, as a broken wire or loose strand of wire can also give the electricity a path to
